5SQ-ABS-BC

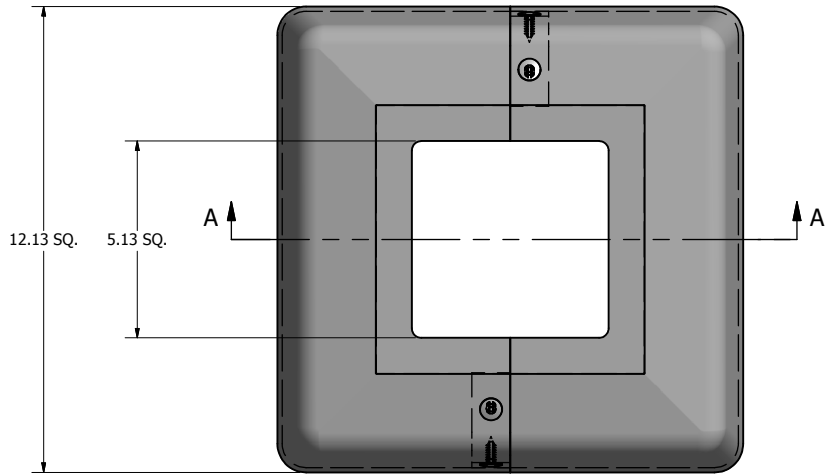
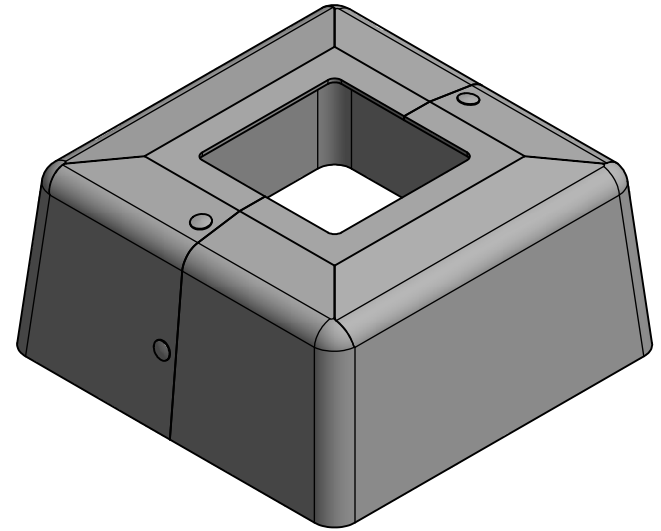
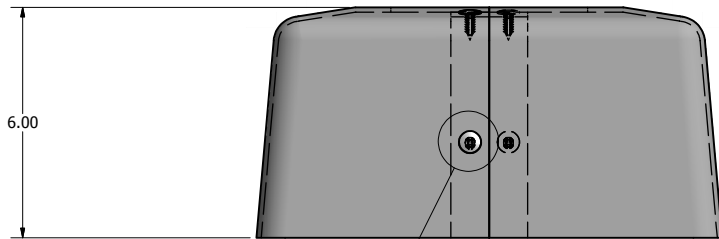
BASE COVER FASTENED
TOGETHER WITH 4
PUSH PINS.
